MARYLAND GEOLOGICAL SURVEY
Merryman Hall
The Johns Hopkins University
Baltimore, Maryland 21218
(301) 235-0771

COUNTIES (MD/PA) FREDERICK/ADAMS
M&D milestone no. 88 (91)
MHT-HSI no. F-6-37

FIELD SHEET: MASON & DIXON LINE, MARYLAND-PENNSYLVANIA BOUNDARY MARKER SURVEY

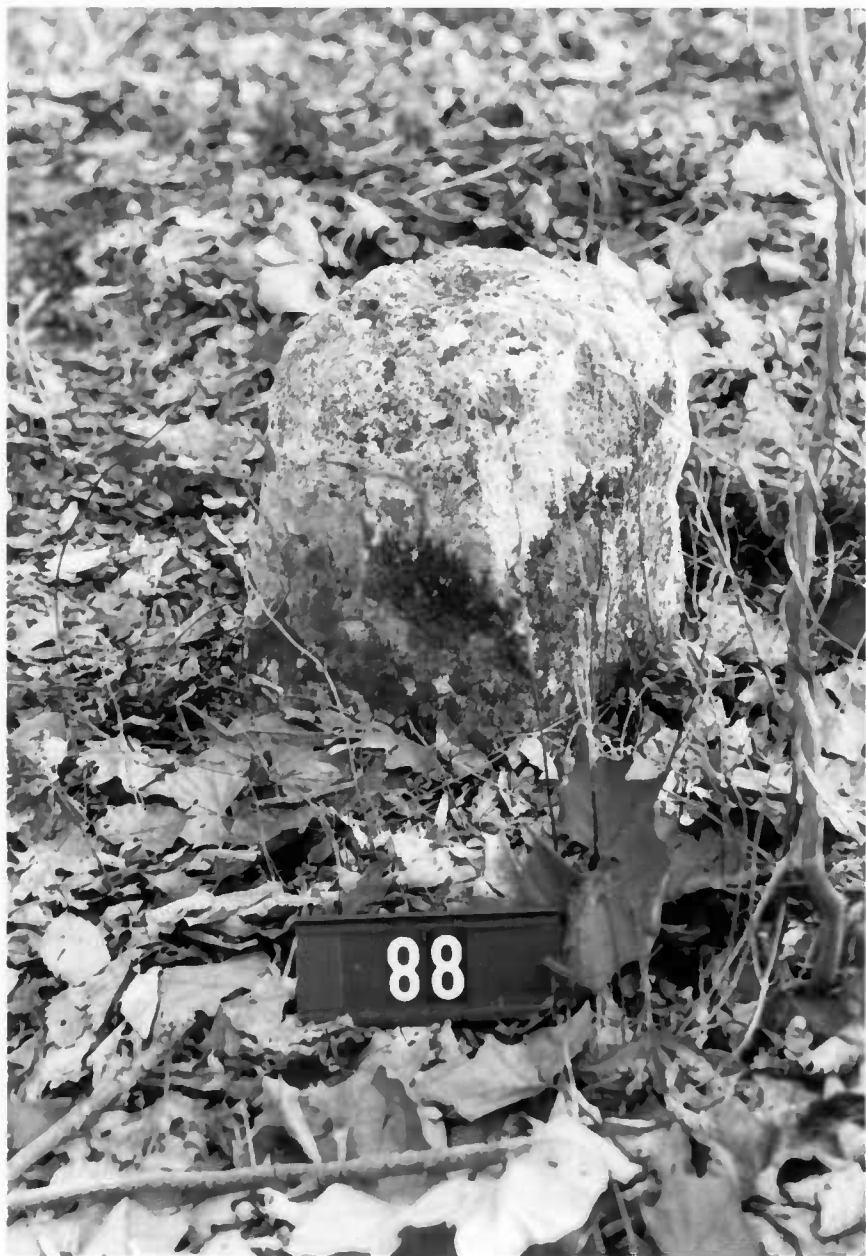
HANSEN & DIXON WEST LINE: MILESTAGE 08(91)
NW CORNER (P1-)
ORIGINAL (1767)

N face (PA): 11 1/4" wide x 13 1/2" high; P discernible, but circle panel, fluting & margins gone; chips all edges & over face

W face: 11 1/4" wide x 13" high; no fluting or margins remain; huge chips all edges & face

88 (91). Original M&D milestone 88 (91) in place (according to 1900-03 Resurvey map, but not at quad location), in deteriorated condition, firmly set. P discernible, but M half gone; huge chunks all top corners, edges, surfaces. (over)

Dome-shaped, weathered and badly defaced. Darkened as though in flood plain. Protected by site.

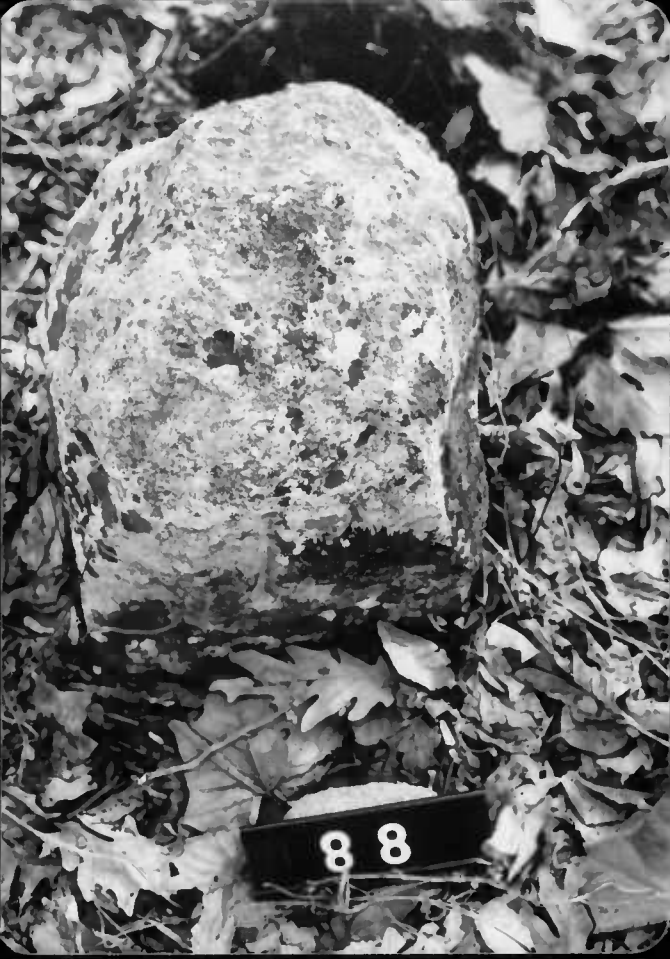
MED WEST LINE: MILESTONE 88 (91)
CLOSEUP OF N/S E TOP

top: no planes or fluting remain; dome-shaped from chips & weathering; huge chips all corners

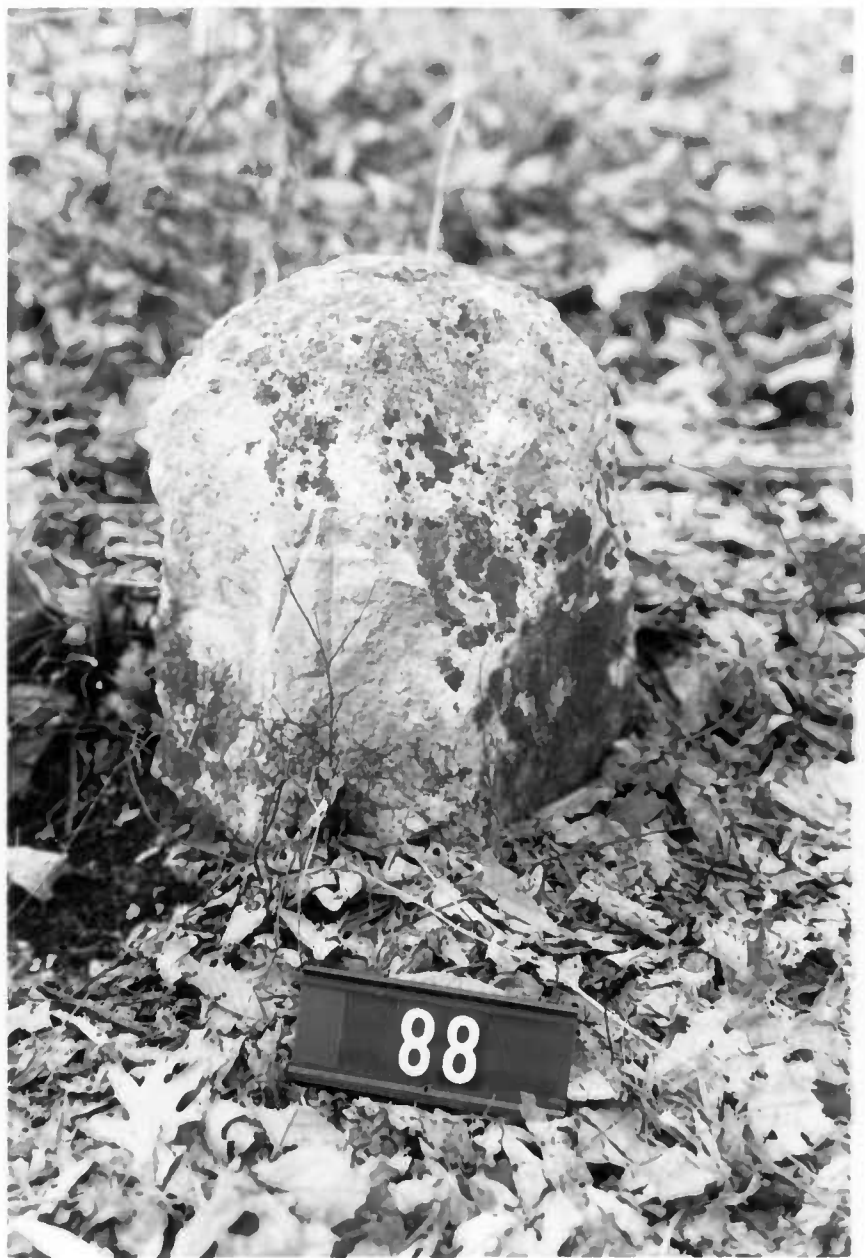
MASON DIXON WEST LINE: MILSTONE SS (91)
SE CORNER (M-)
ORIGINAL (1767)

E face: 11 1/4" wide x 14" high; bits of fluting, no margins; chunks out of all edges & face

S face (MD): 11 1/4" wide x 14" high; half of M gone; no circle panel, fluting or margins remain; huge chunks out of edges & face
